Investigation Report
Gasoline on TK38 External Floating Roof

Report Date: 04/07/11

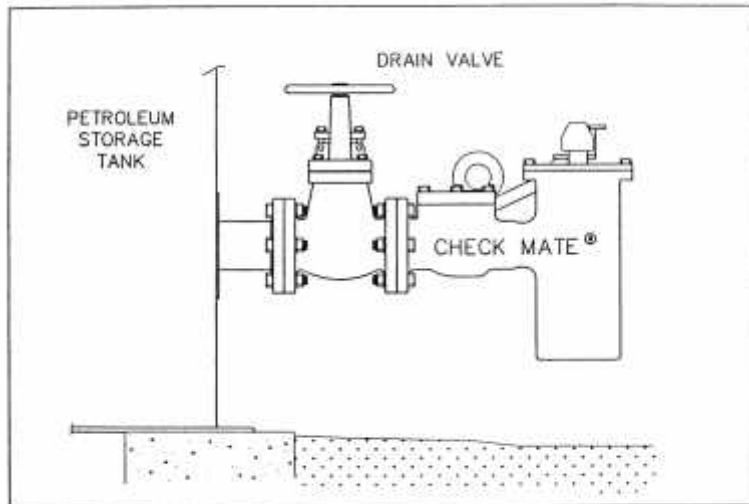
Figure 3: Check Mate Hydrocarbon Sensing Valve Outline

The hydrocarbon sensing element in the Check Mate valve was found to be coated with green algae. The flange face and check valve seating surface were also found to be corroded beyond repair.

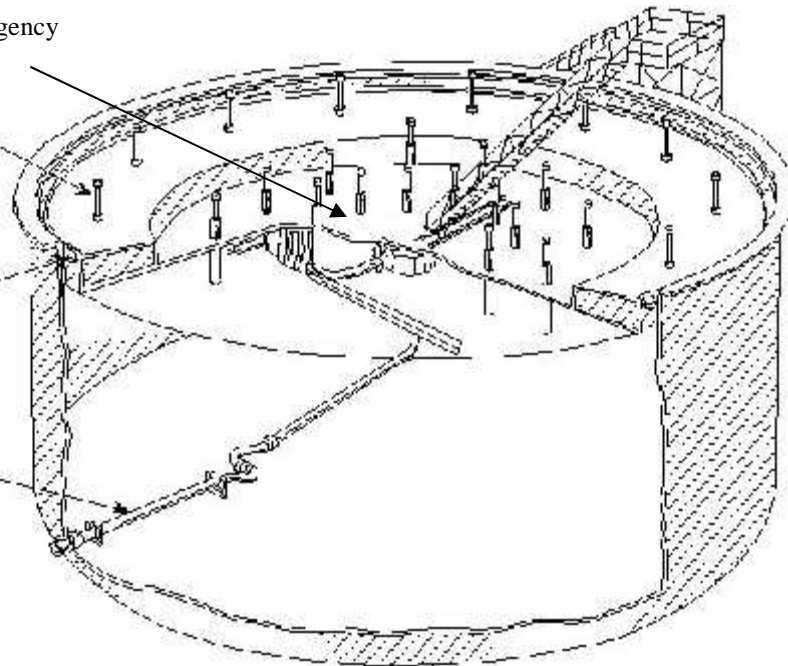
Figure 5: Annular Pontoon Single Deck EFR Tank

According to PEI, the liquid level was observed to be about 4" below the inlet to the emergency overflow drain line after all the liquid was removed from TK38 roof.
